# Manhole Inspection Summary

Manhole # S45I\_\_033MH

Insp Date: **4/24/08 10:52 AM**

**Location** Address: **2029 s castle st**

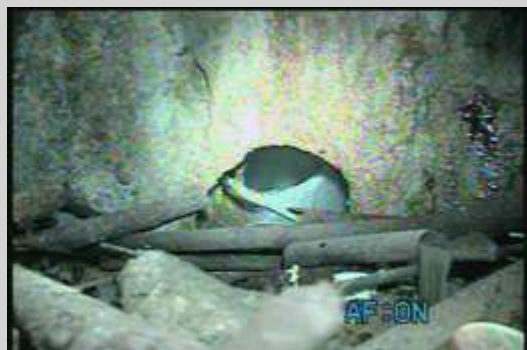
12 O'Clock Outflow

8 in. Circular Gravity Sewer  
Drop Out @ 12 O'Clock

Infiltration: **None** Pipe Seal Cond: **Unknown**
